## 6.3 ARCHITECTURAL COMPONENTS

### 6.3.2 INTERIOR PARTITIONS

#### 6.3.2.1 INTERIOR PARTITION WALLS, HEAVY

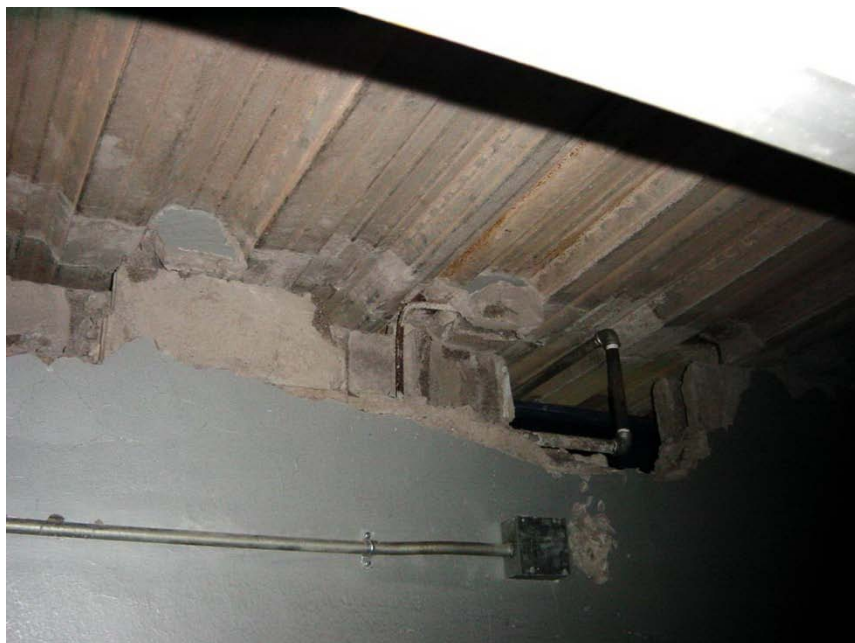
Figure 6.3.2.1-1 Damage along the top of a reinforced concrete masonry unit partition built flush with soffit of metal deck at an industrial facility in the 2001 magnitude-8.4 Peru Earthquake (Photo courtesy of Eduardo Fierro, BFP Engineers).

- Heavy full height partitions need out-of-plane restraint with an in-plane slip joint. This can be provided with steel angles on either side attached to the structural slab above as shown. Steel angles may be continuous or intermittent; check code requirements. Note that special details may be required to meet fireproofing, sound proofing, weatherproofing or insulation requirements.
- Care must be used in detailing slip joints for a series of interconnected perpendicular walls since the out-of-plane restraints for one wall will prevent in-plane slip along the perpendicular wall; vertical isolation joints may be required. Similarly, special details are required where the soffit of the structure above has an irregular profile that would prevent slip such as the metal deck in Figure 6.3.2.1-1, or a sloping profile such as a ramp.

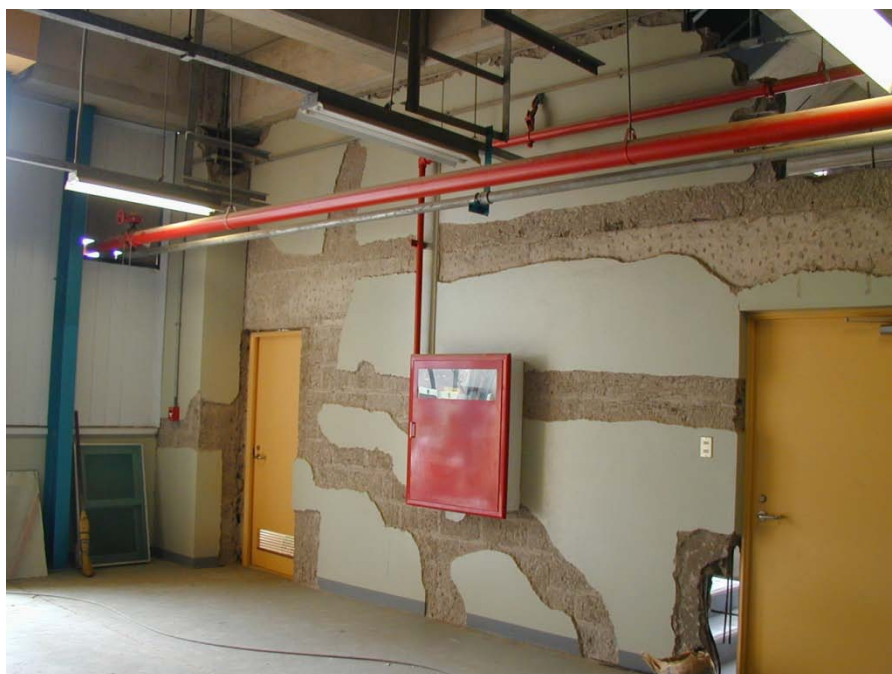
Figure 6.3.2.1-2 Damage to reinforced concrete masonry partition used to support fire protection cabinet and piping in the 2001 Peru Earthquake; loose stucco and masonry were removed prior to photo (Photo courtesy of Eduardo Fierro, BFP Engineers).

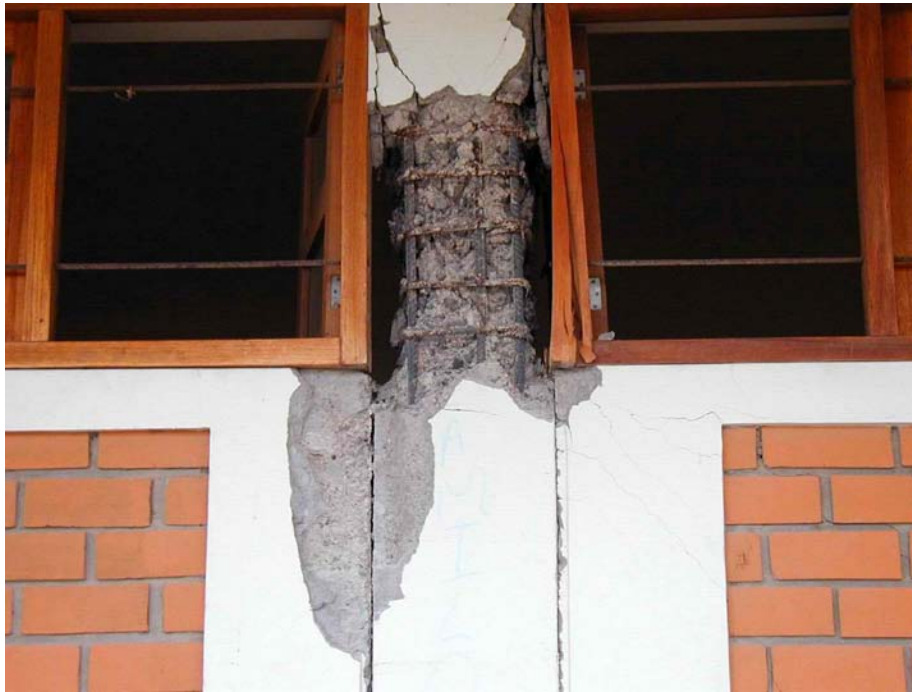
Figure 6.3.2.1-3      Damage to structural column ("captive column") due to restraint caused by partial height masonry wall in the 2001 Peru Earthquake (Photo courtesy of Eduardo Fierro, BFP Engineers).

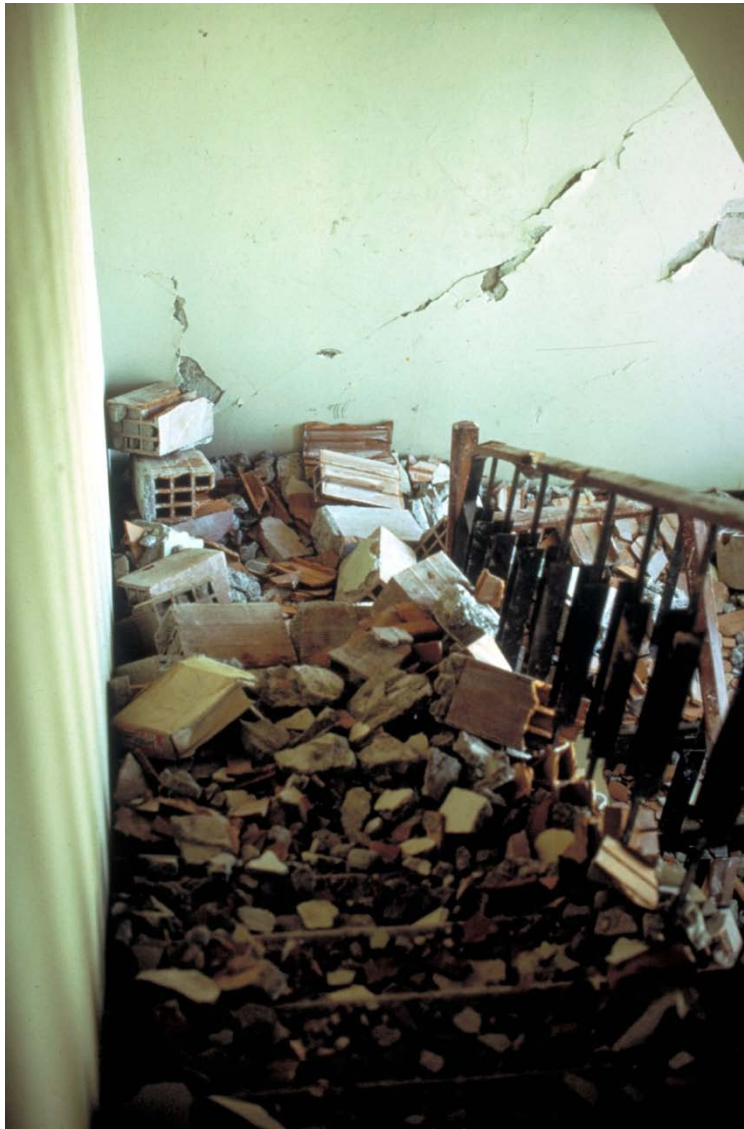
Figure 6.3.2.1-4 View of stairway in the Banco Central Building, Managua, Nicaragua after the 1972 magnitude 6.2 Managua Earthquake. Most of the stairs were covered with debris that resulted from the failure of the hollow tile partitions surrounding the stairs (Photo courtesy of PEER Godden Collection, No. J94).

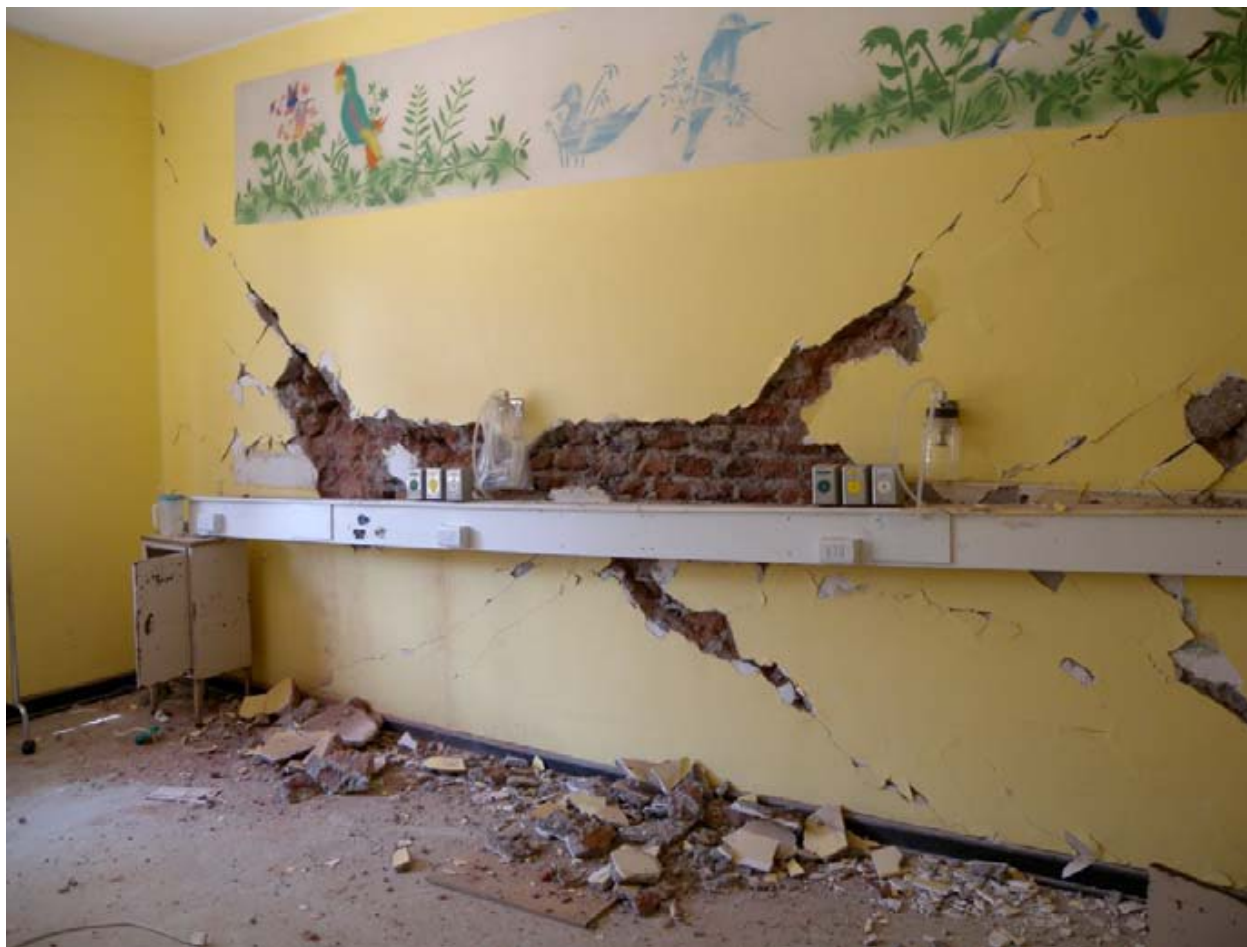
Figure 6.3.2.1-5 Damage to unreinforced brick partitions in patient rooms, and other mostly nonstructural damage, resulted in the evacuation of the Felix Bulnes Hospital in Santiago in the 2010 magnitude-8.8 Chile Earthquake (Photo courtesy of Gilberto Mosqueda, University of Buffalo, SUNY).

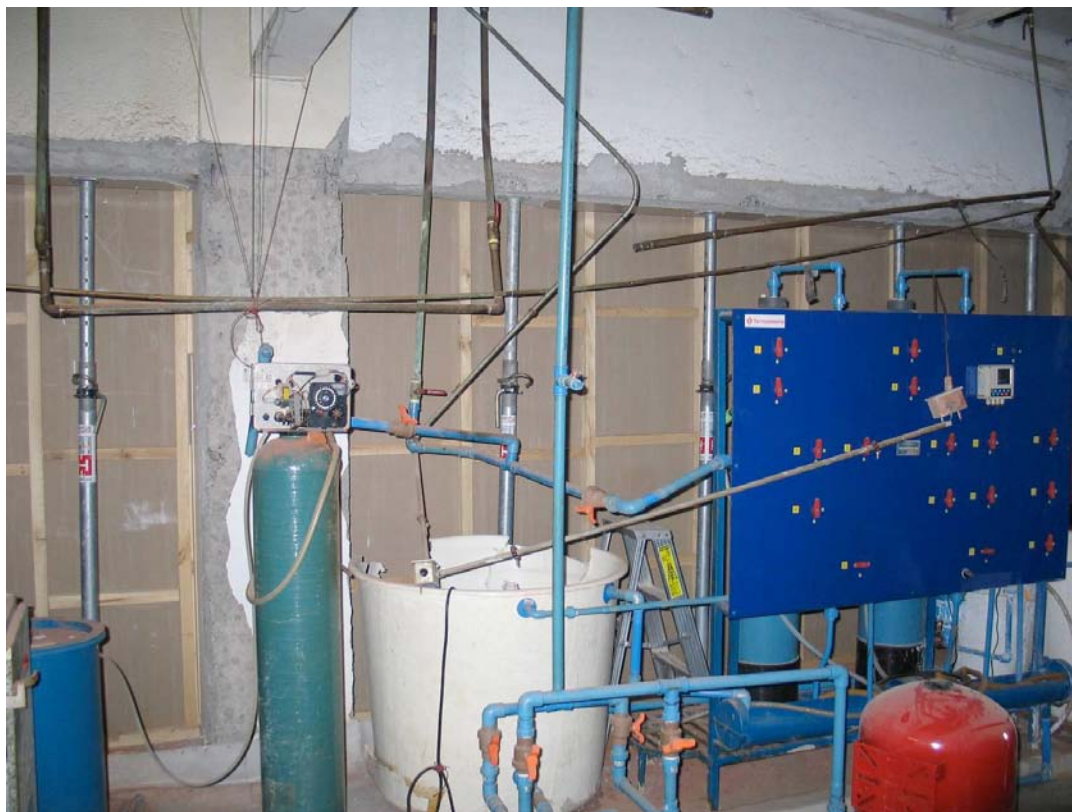
Figure 6.3.2.1-6 An infill masonry wall collapsed onto the distilled water equipment spilling two 150 gallon containers; water leaked past the perimeter edge of the floor slab into the operating room suite below resulting in the closure of 3 of 6 the operating rooms. Replacement gypsum board partition seen in photo. Hospital built in 2005 in Los Angeles, Chile. Damage from the 2010 Chile Earthquake (Photo courtesy of Bill Holmes, Rutherford & Chekene).

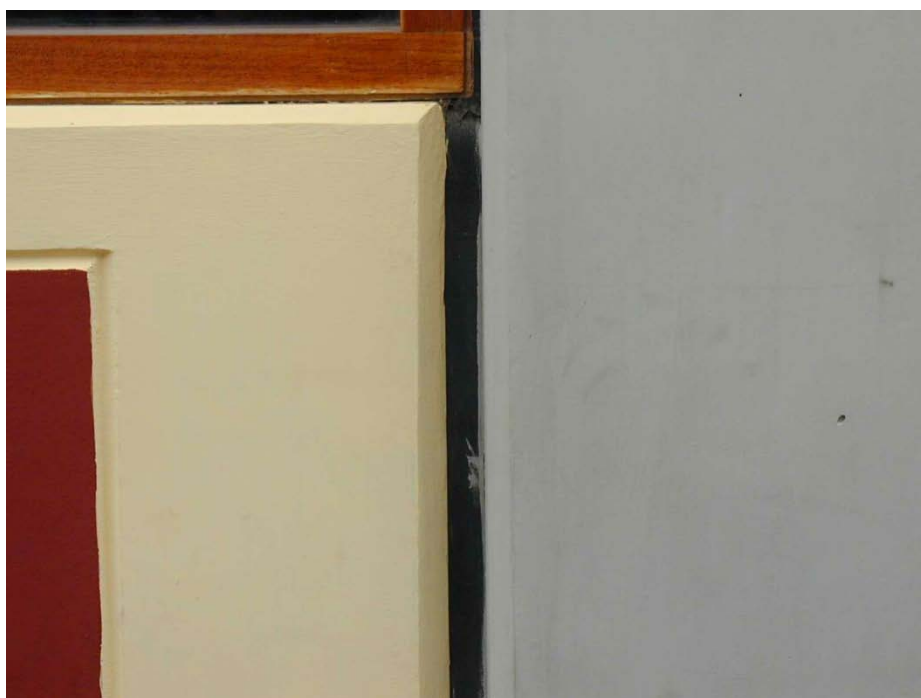
Figure 6.3.2.1-7 Detail of isolation joint to prevent creation of “captive column” condition (Photo courtesy of Eduardo Fierro, BFP Engineers).

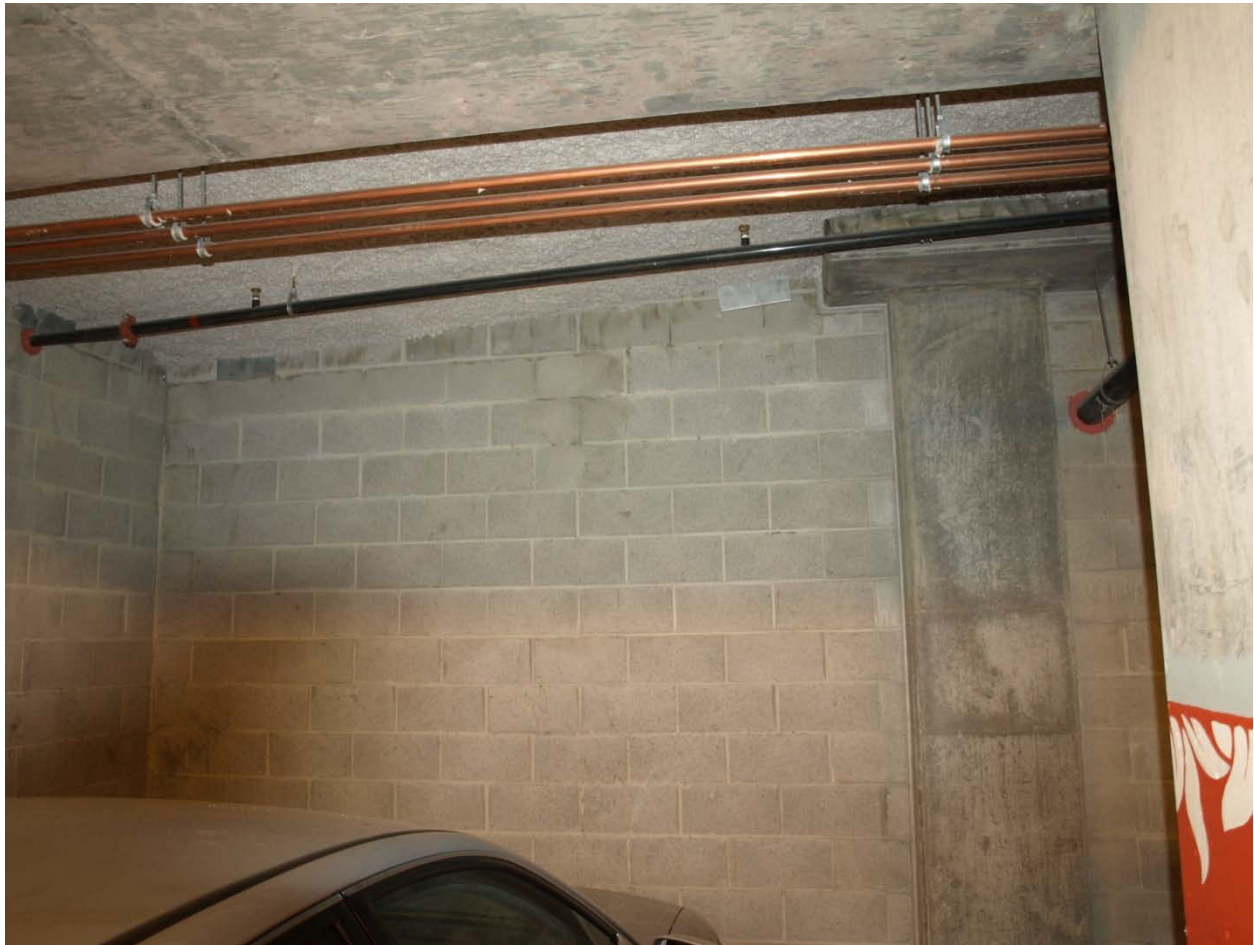
Figure 6.3.2.1-8 Full-height concrete masonry unit walls detailed with steel clip angles (3 angles visible in photo). Configuration shown includes perpendicular walls, sloping ramp above, and column with column capital. Although wall detailed with sealant joints along edges of column and column capital, it is not clear that the concrete frame can move independently of these CMU walls (Photo courtesy of Cynthia Perry, BFP Engineers).

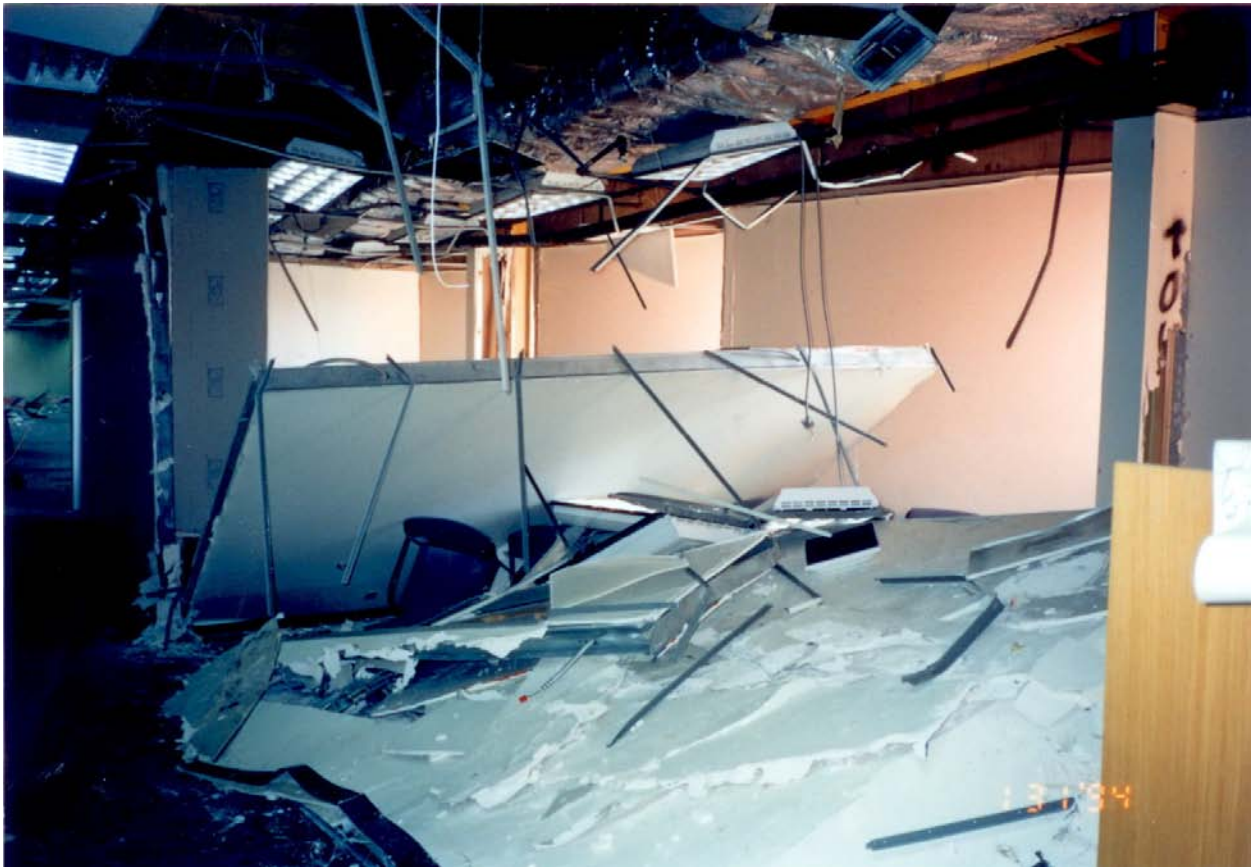
Figure 6.3.2.2-1 Failure of inadequately braced partial height metal stud partitions in the 1994 Northridge Earthquake (Photo courtesy of Wiss, Janney, Elstner Associates).

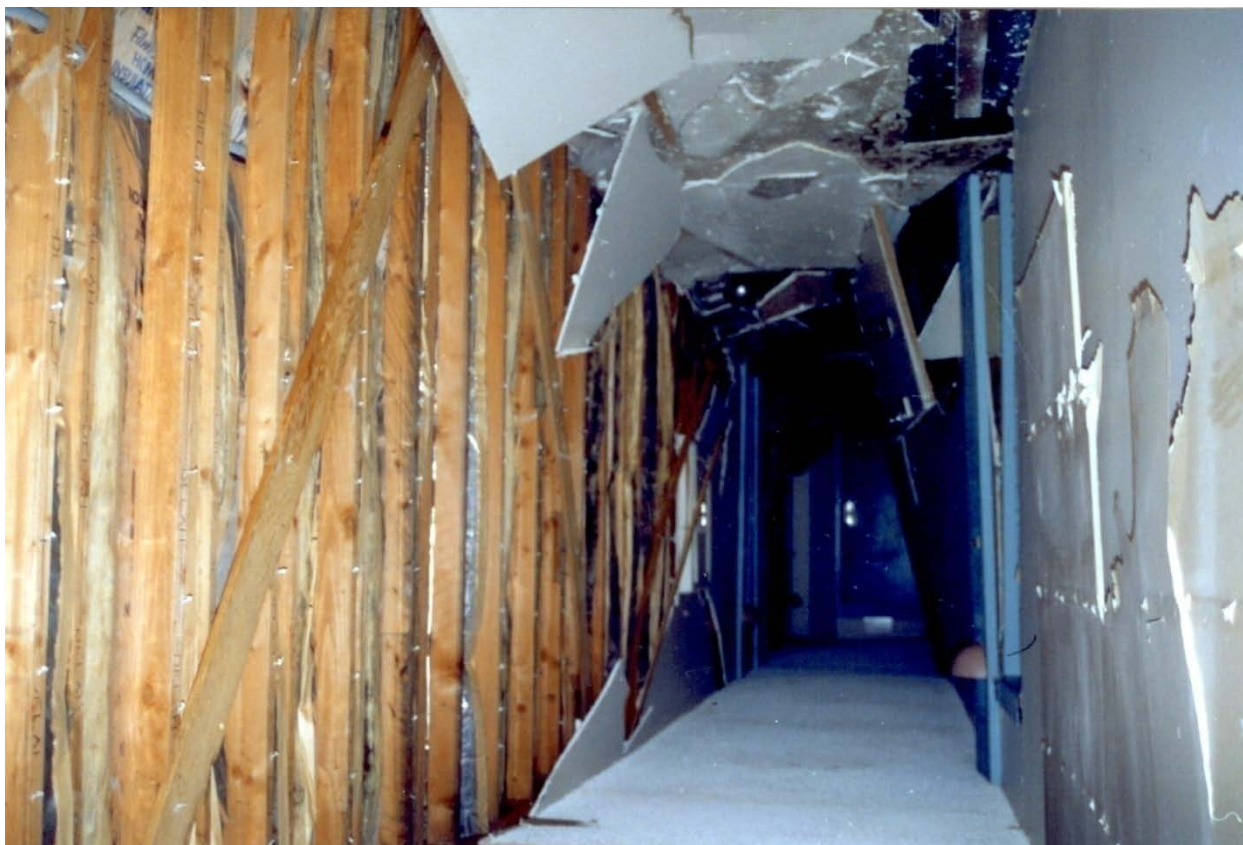
Figure 6.3.2.2-2 Damage to wood stud wall spanning floor-to-floor in the 1994 Northridge Earthquake (Photo courtesy of Wiss, Janney, Elstner Associates).

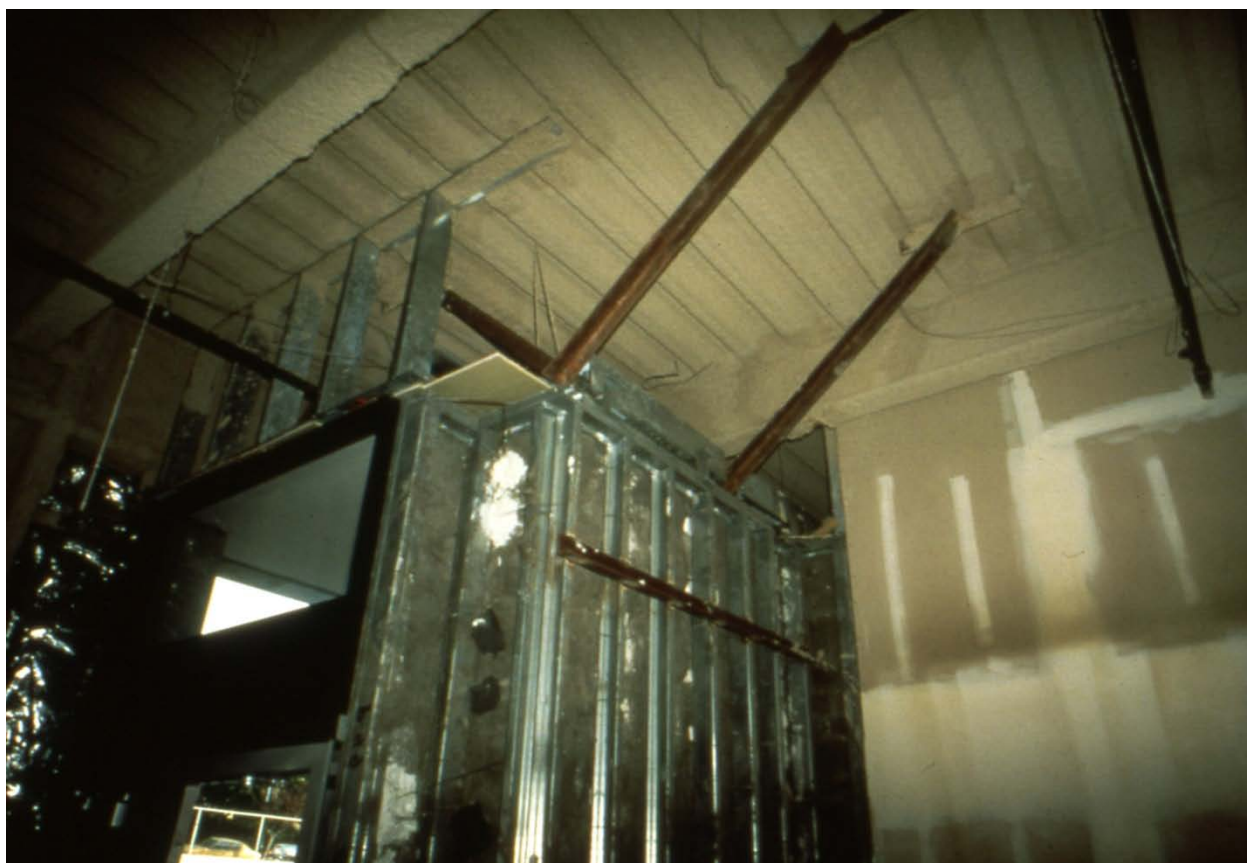
Figure 6.3.2.2-3      Bracing of partial height stud partition (Photo courtesy of Degenkolb Engineers).

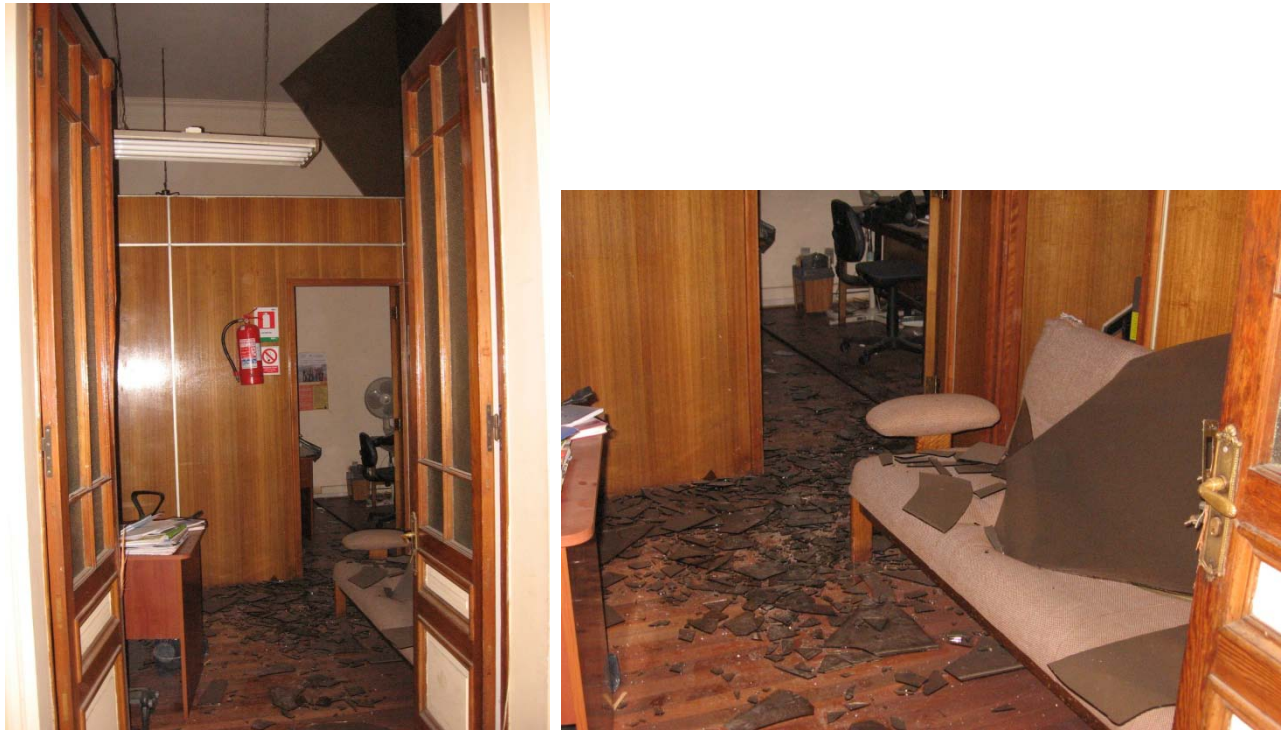
Figure 6.3.2.3-1 Glass shards fallen from the top of partial height office partitions in the reception area during the magnitude-8.8 2010 Chile Earthquake (Photo courtesy of Rodrigo Retamales, Rubén Boroschek & Associates).

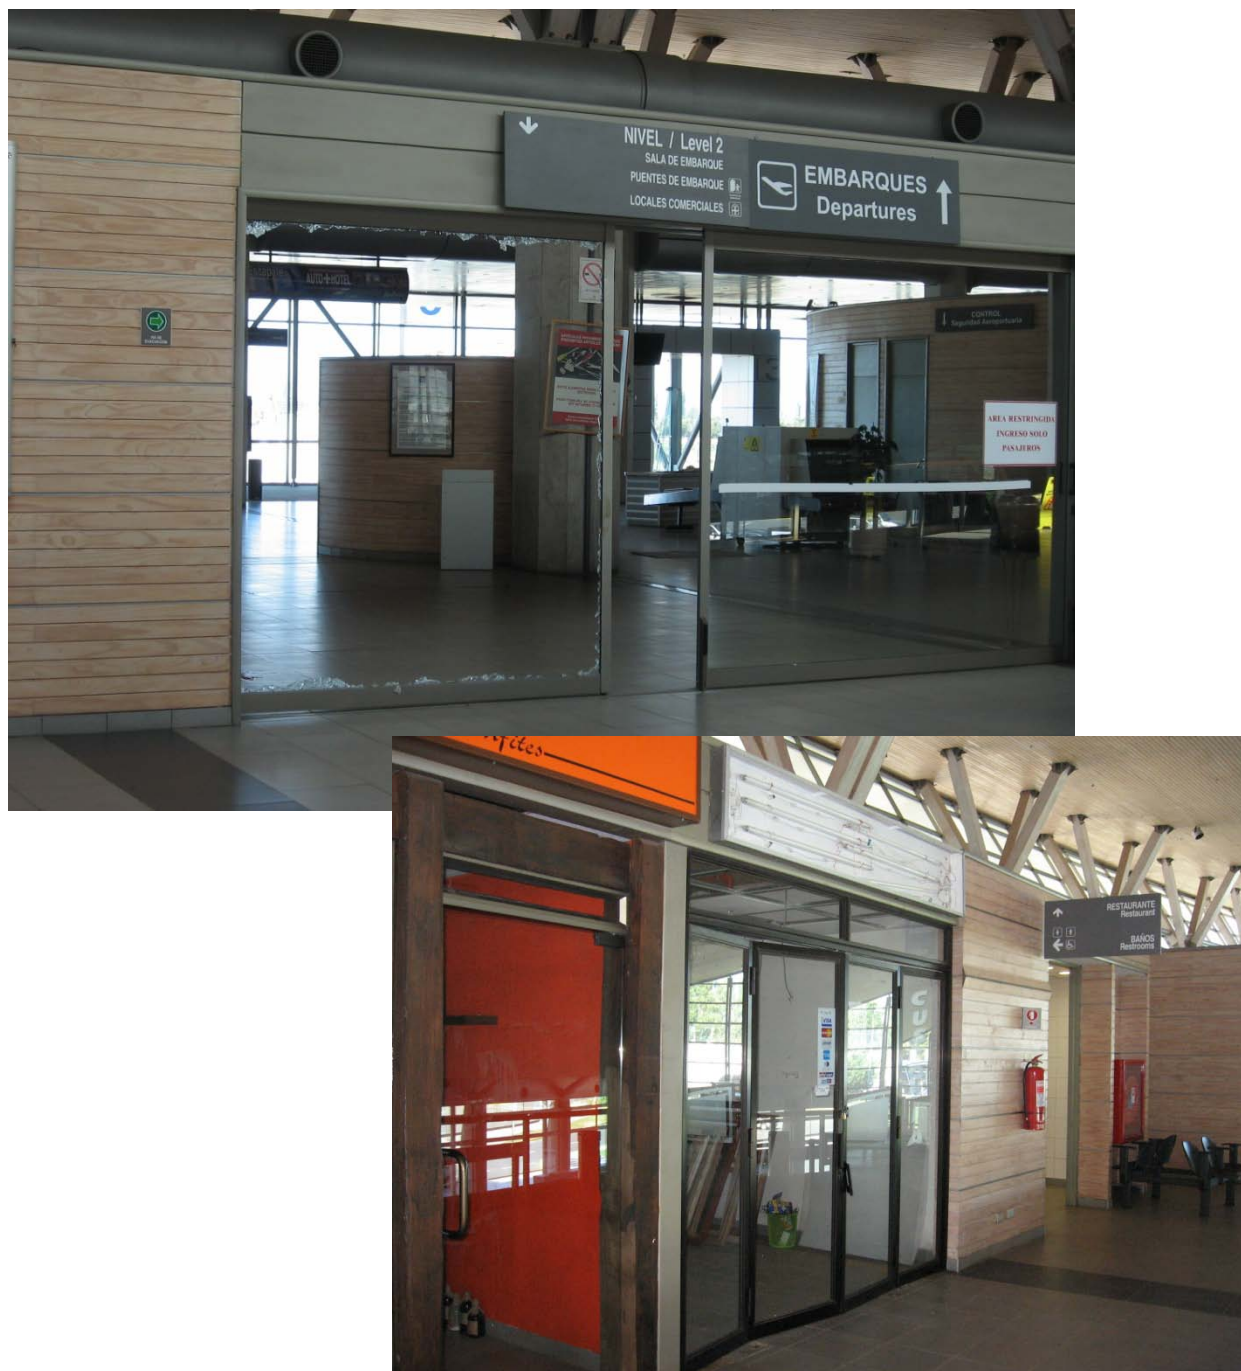
Figure 6.3.2.3-2

Damage to glazed doors at the Concepción airport in the 2010 Chile Earthquake. In the top photo the glazing in the sliding glass door shattered; in the lower photo the glass is intact but the door frames are misaligned (Photos courtesy of Rodrigo Retamales, Rubén Boroschek & Associates).

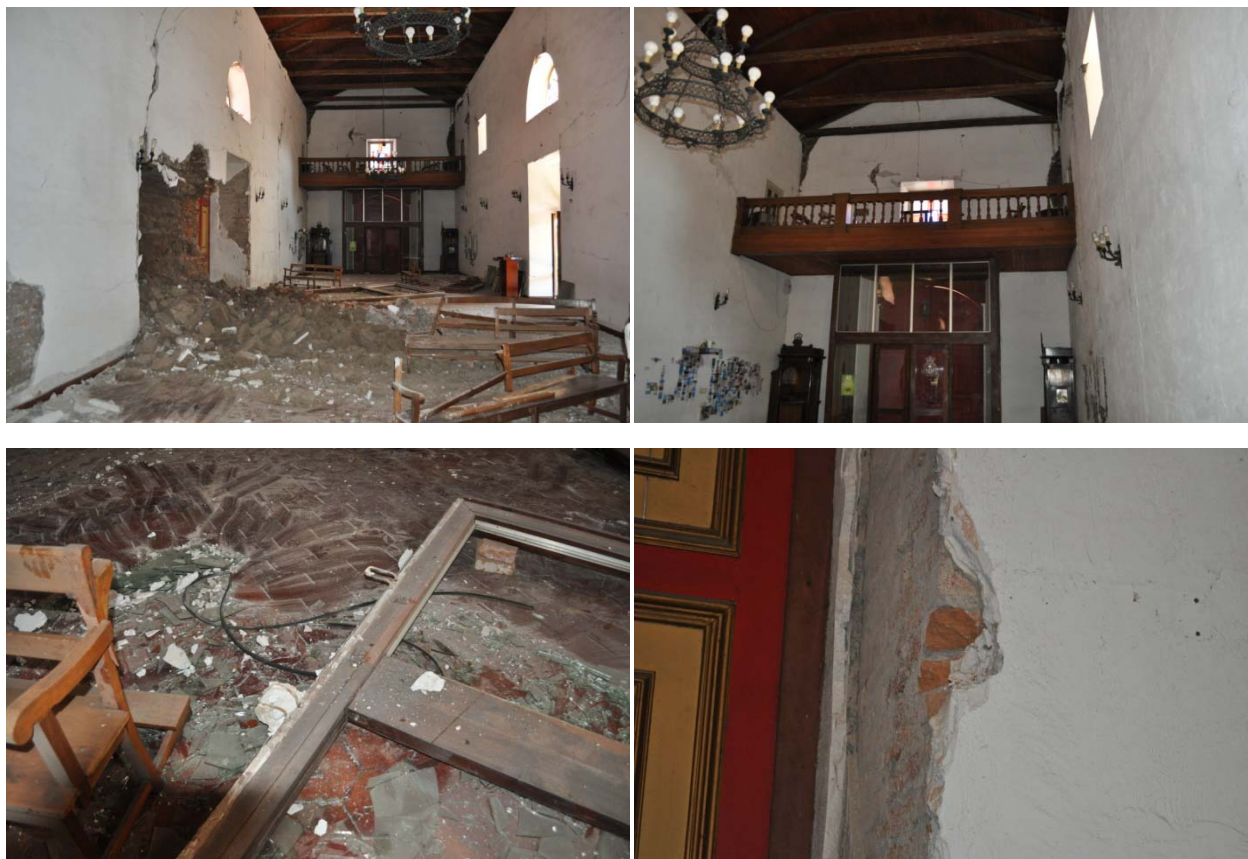
Figure 6.3.2.3-3 Failed wood framed glazing assembly in the 2010 Chile earthquake (Photo courtesy of Eduardo Fierro, BFP Engineers). The wood framing was held in place by metal or rebar brackets embedded in the masonry wall. The adobe wall on the left of the door collapsed and the brackets on the right side pulled out of the brick masonry wall (lower right). The glazing assembly at the rear entrance of the chapel was anchored overhead to the wood balcony framing and was undamaged.

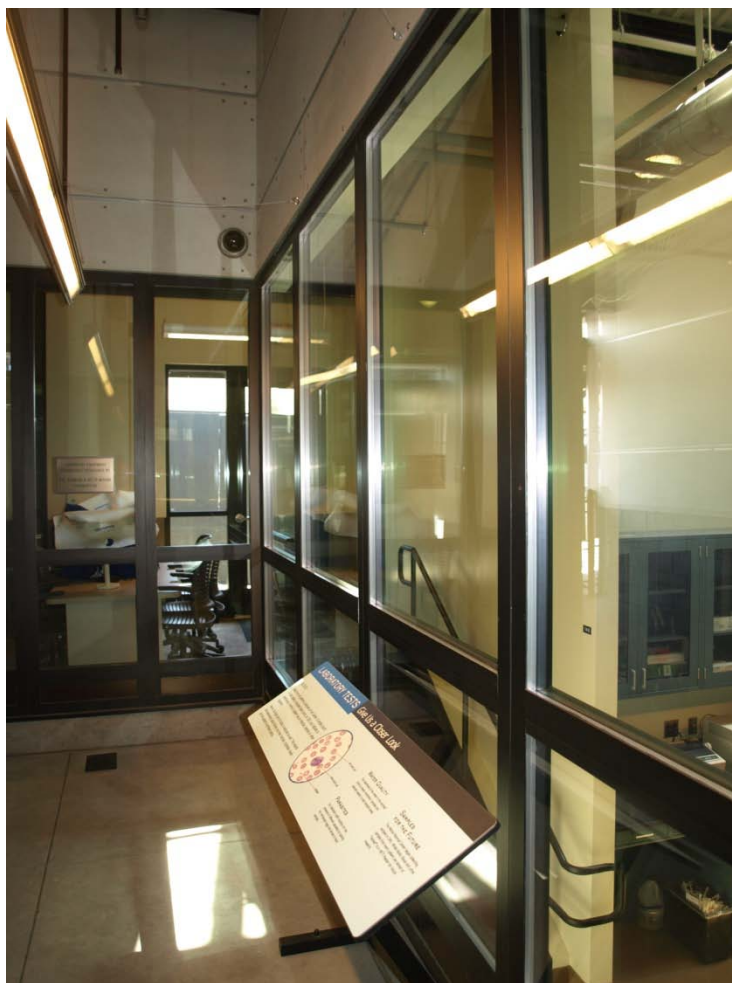
Figure 6.3.2.3-4 Glazed partition supported at base with slip track at top; partition above glazing suspended and braced from above. Glazing subdivided into relatively small panels with ample clearance at mullions (Photo courtesy of Cynthia Perry, BFP Engineers).

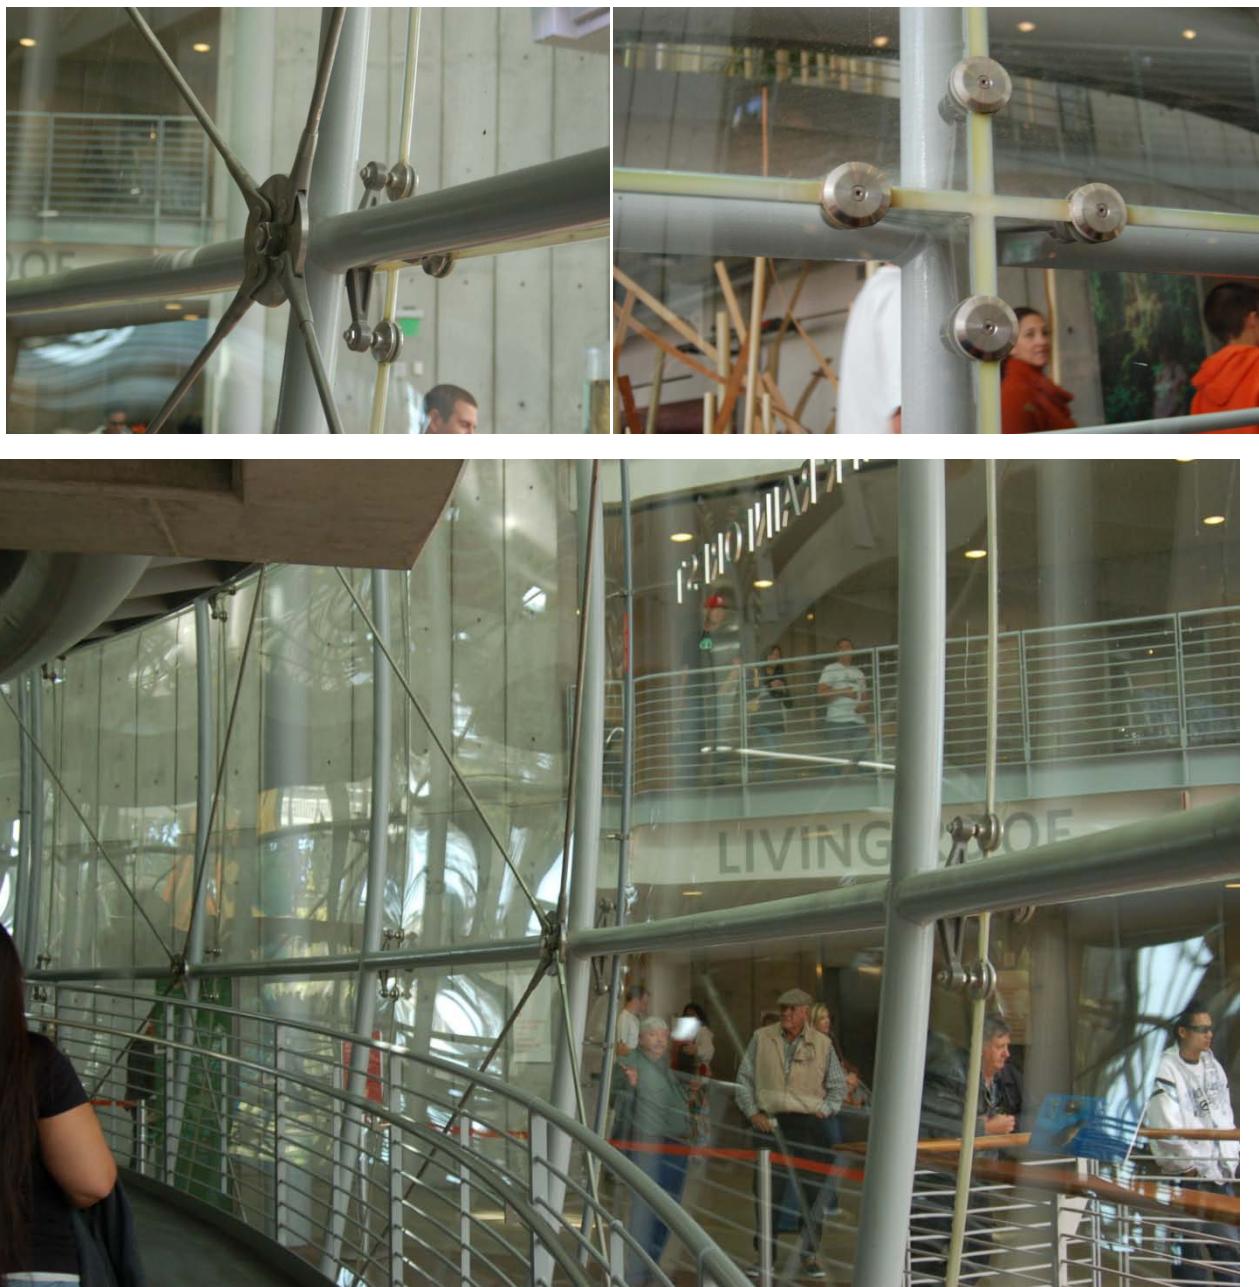
Figure 6.3.2.3-5

Specialized glazing details for glass dome using specialty hardware, such as large sealant joints required to accommodate thermal movement and seismic deformations at the California Academy of Sciences, San Francisco, California (Photos courtesy of Cynthia Perry, BFP Engineers).

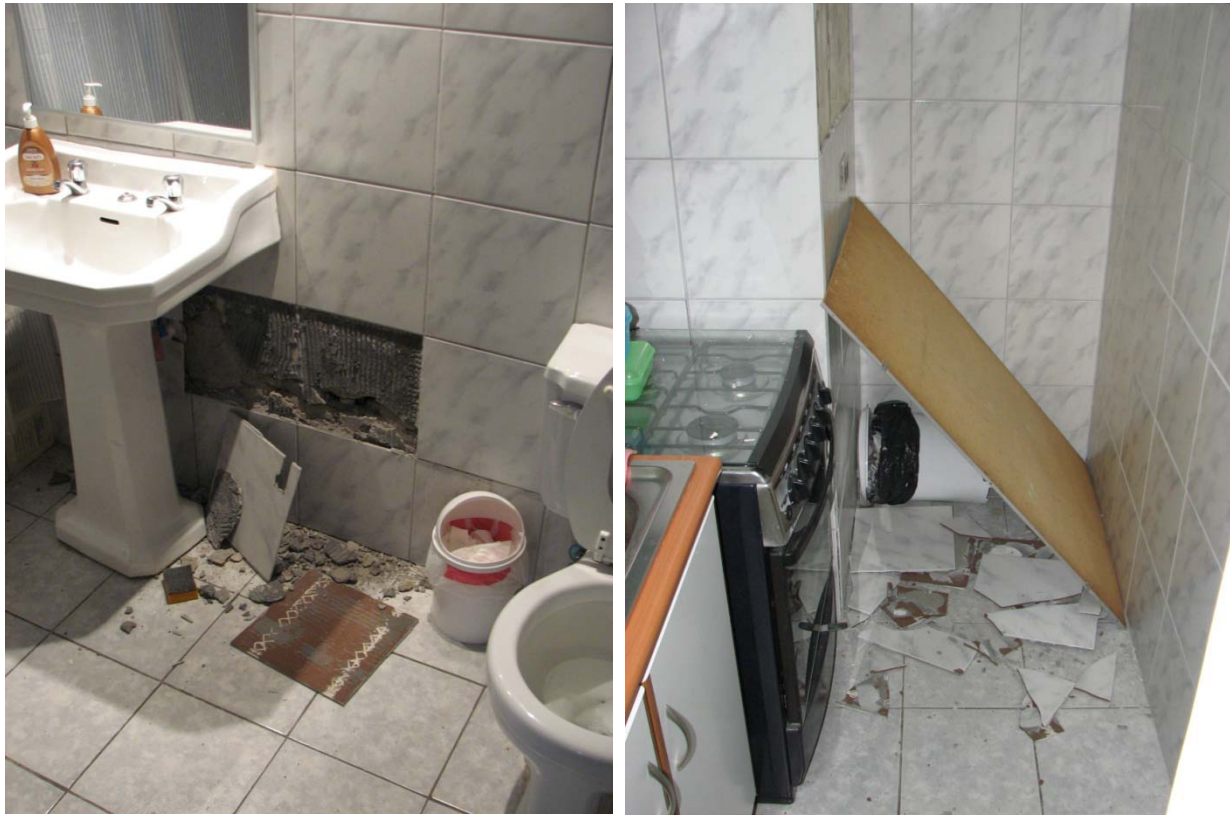
Figure 6.3.3.1-1 Damage to adhered tile veneer in residential bathroom and kitchen in the 2010 magnitude-8.8 Chile Earthquake (Photo courtesy of Antonio Iruretagoyena, Ruben Boroschek & Associates). Tile is adhered to CMU infill partitions.

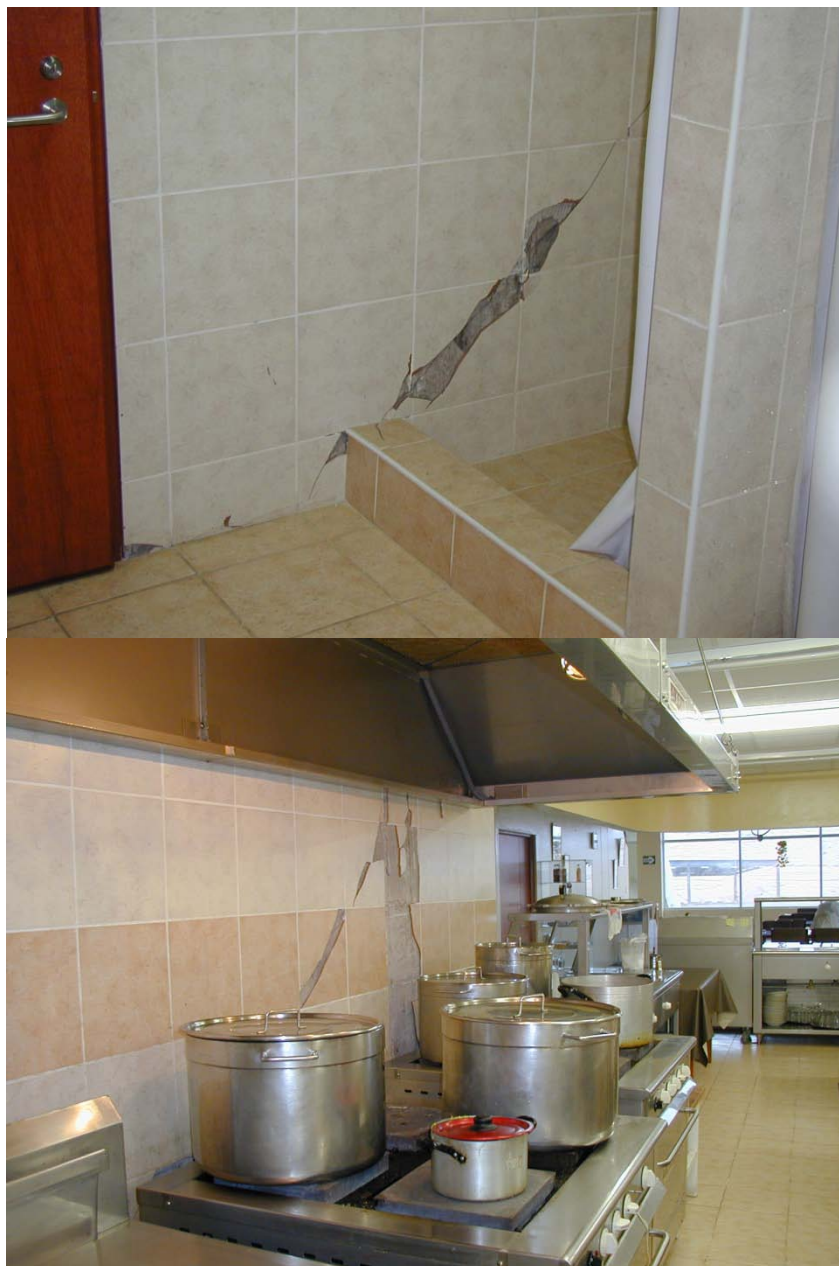
Figure 6.3.3.1-2 Damage to adhered tile veneer in locker room and kitchen at industrial facility in the 2001 Peru Earthquake (Photo courtesy of Eduardo Fierro, BFP Engineers). Tile was adhered to CMU partitions which were built integral with the concrete frame. While only a limited number of tiles were broken, equipment had to be disconnected and many tiles removed to repair cracks in the wall and facilitate the repair of the veneer.

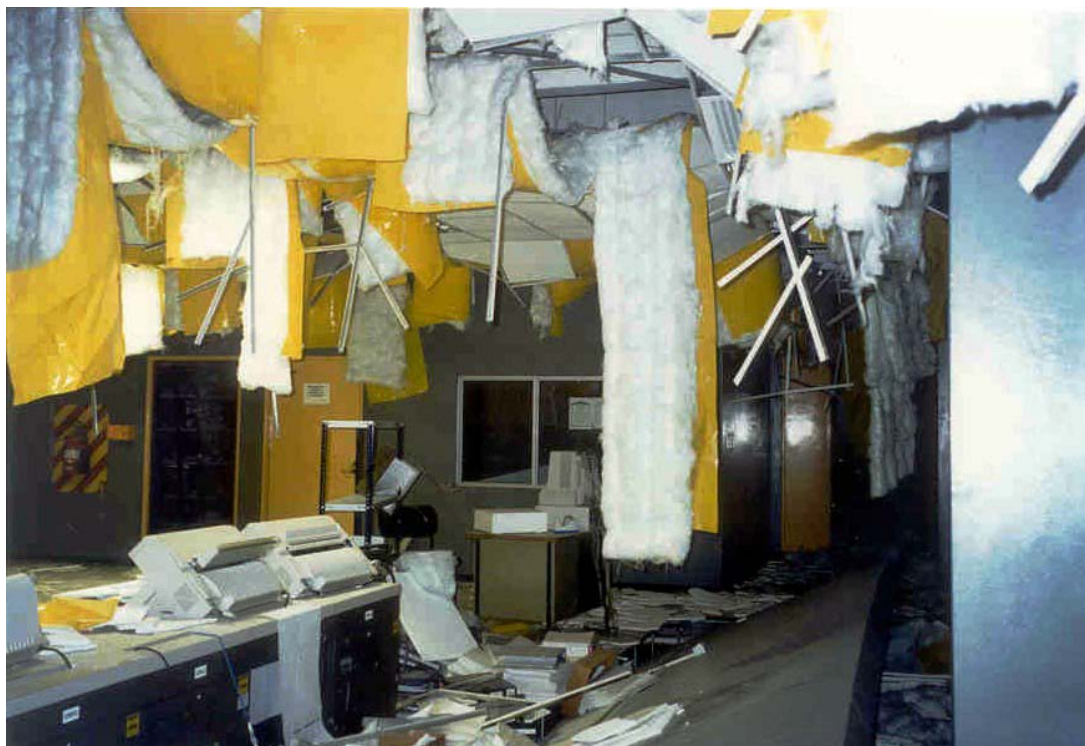
Figure 6.3.4.1-1 Failure of suspended ceiling system including lights, air diffusers, and insulation in control room of an industrial plant in the 2001 magnitude-8.4 Peru Earthquake (Photo courtesy of BFP Engineers).

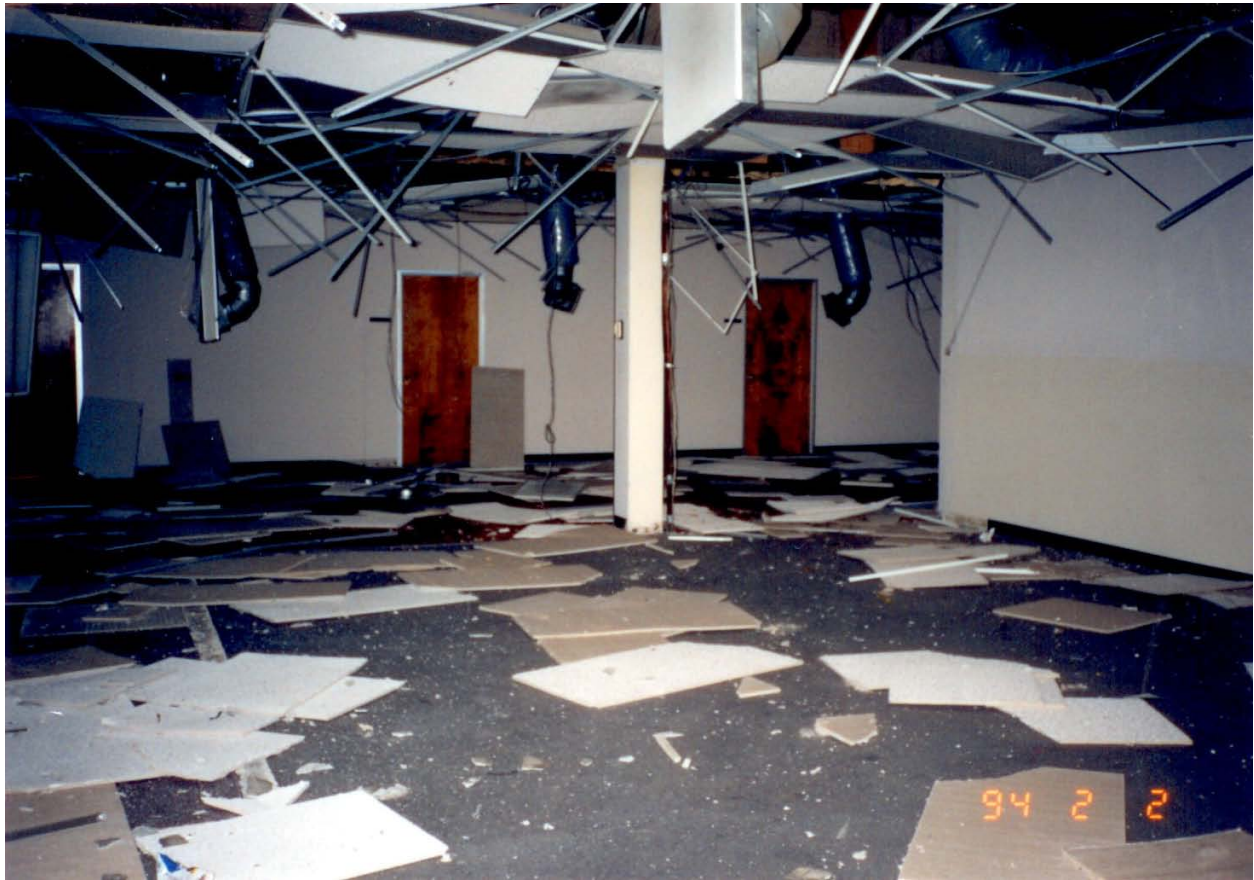
Figure 6.3.4.1-2 Failure of suspended ceiling system including lights and air diffusers in the 1994 Northridge Earthquake (Photo courtesy of Wiss, Janney, Elstner Associates).

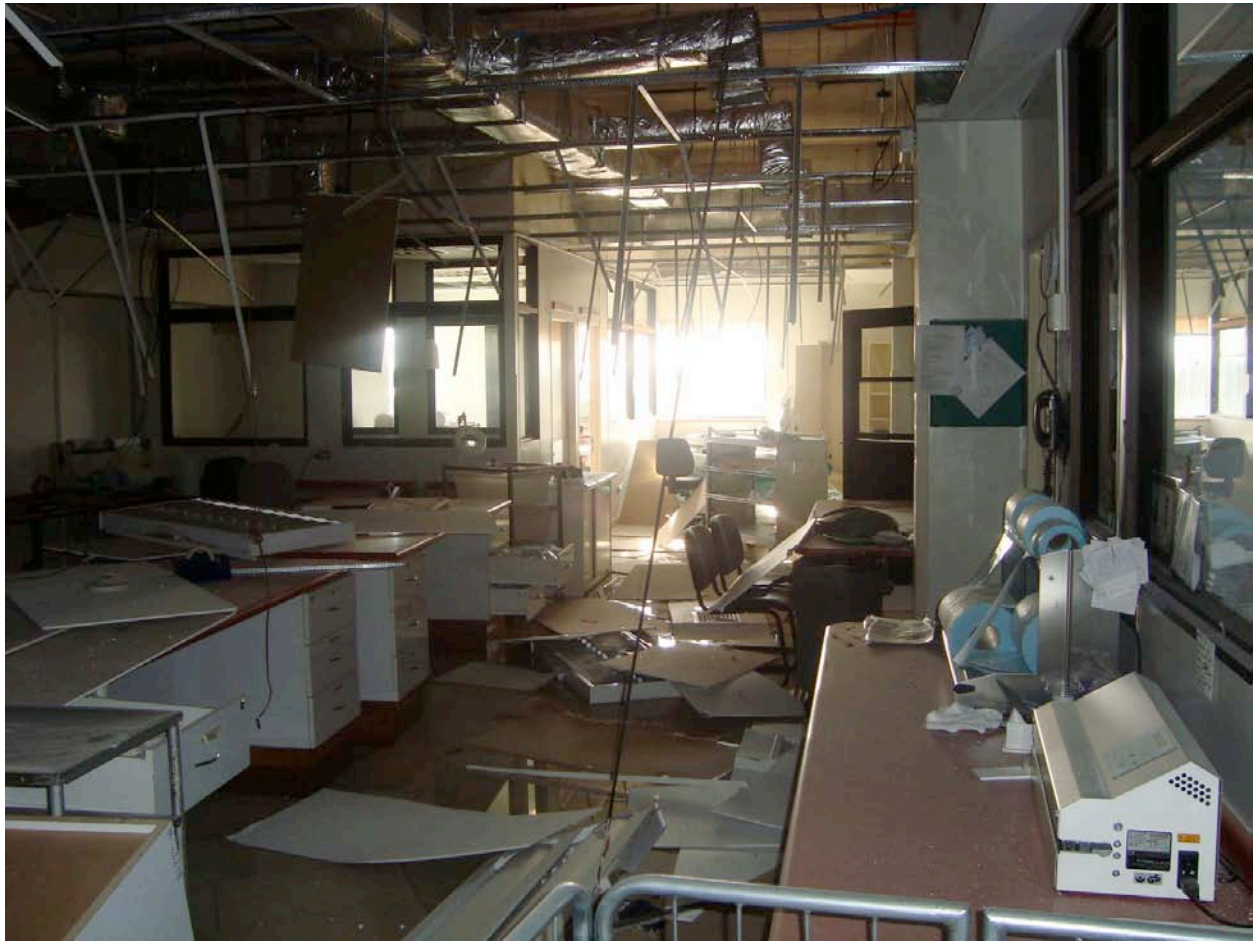
Figure 6.3.4.1-3 Generalized failure of ceiling grid, tiles, lights, and diffusers at the Los Angeles Hospital in the 2010 magnitude-8.8 Chile Earthquake (Photo courtesy of Bill Holmes, Rutherford & Chekene).
